HISTORIC AMERICAN BUILDINGS SURVEY
INVENTORY

2. NAME *Orrin Thompson Mansion*

DATE OR PERIOD *1832*
STYLE *Greek Revival*
ARCHITECT
BUILDER *Orrin Thompson*

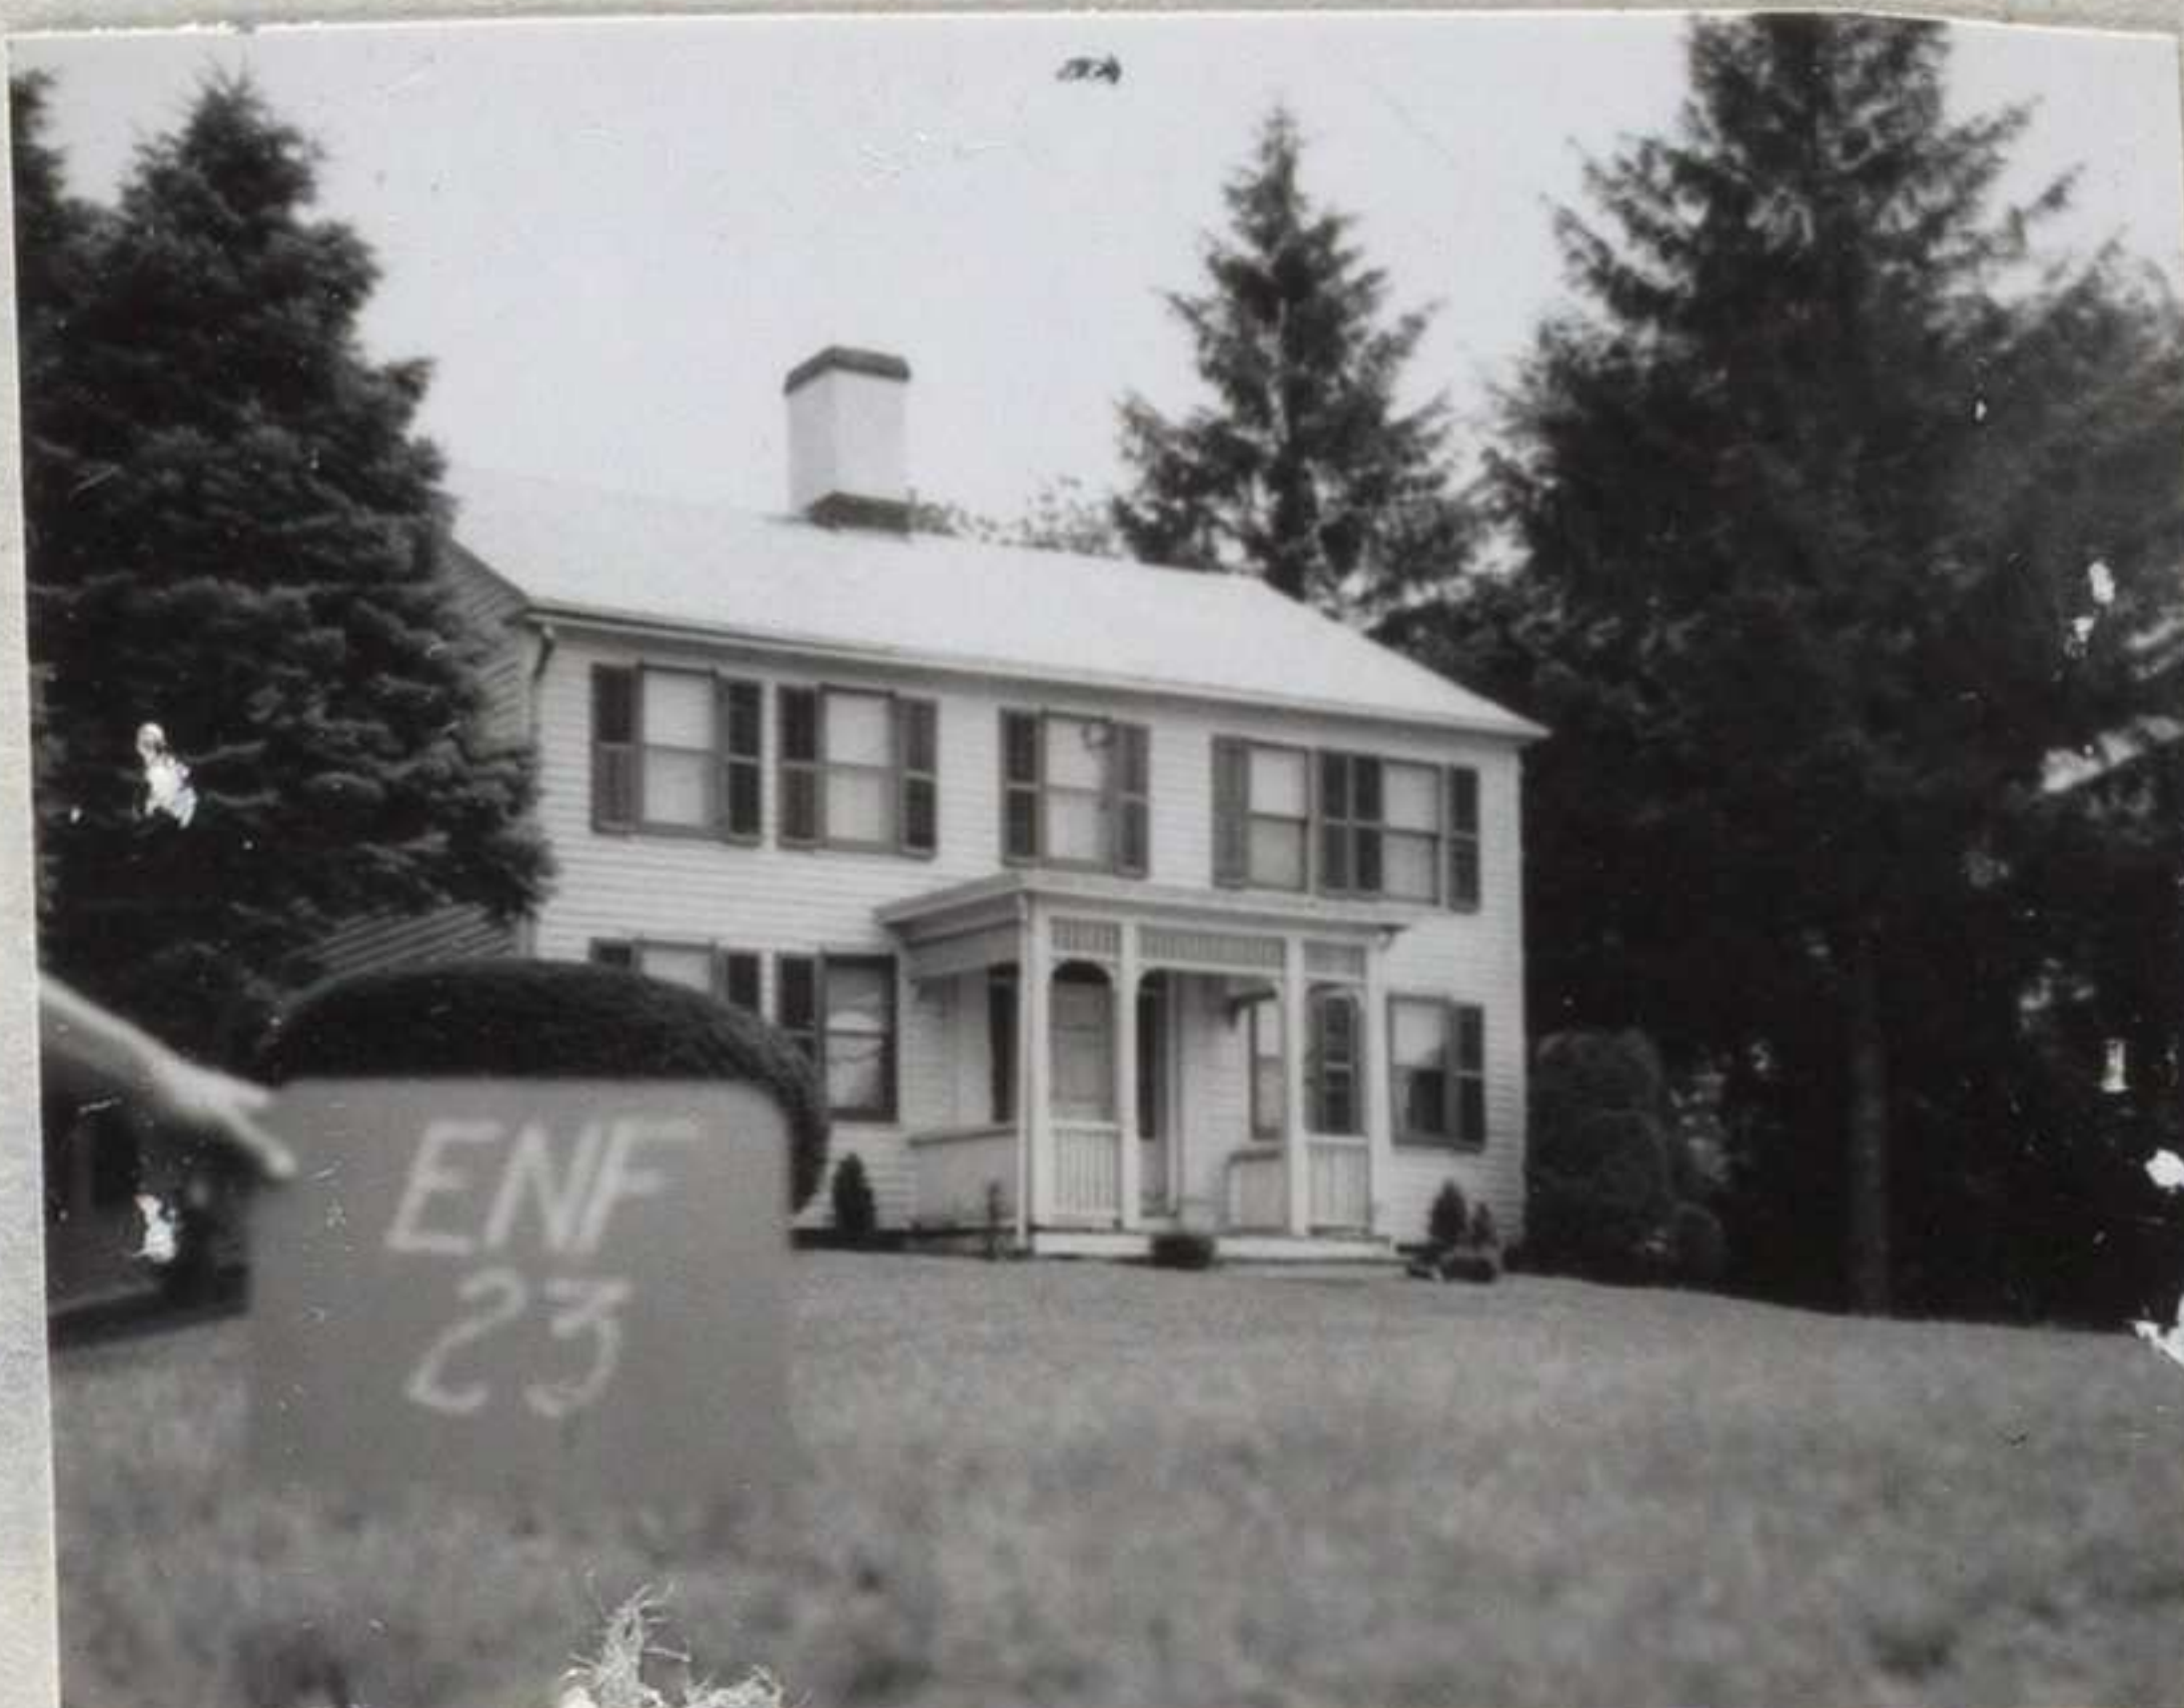
<p>7. PHOTOGRAPH <i>Enf 23</i></p>

<p>1. STATE <i>CT</i> COUNTY <i>Hartford</i> TOWN <i>Enfield</i> VICINITY STREET NO. <i>SE. corner King + Mullen Sts.</i></p> <p>ORIGINAL OWNER ORIGINAL USE <i>Residence</i> PRESENT OWNER <i>Mullen</i> PRESENT USE <i>Residence</i> WALL CONSTRUCTION <i>Clapboard</i> NO. OF STORIES <i>2</i></p>		<p>HISTORIC AMERICAN BUILDINGS SURVEY INVENTORY</p> <p>2. NAME</p> <p>DATE OR PERIOD <i>ca. 1840</i> <i>Federal</i> STYLE <i>Roman Revival</i> ARCHITECT BUILDER</p> <p>3. FOR LIBRARY OF CONGRESS USE</p>	
<p>4. NOTABLE FEATURES, HISTORICAL SIGNIFICANCE AND DESCRIPTION</p> <p>OPEN TO PUBLIC <i>No.</i></p> <p><i>This house has a facade of five bays. The medium pitched roof is centered with a chimney. The fine period door with transom and side lights is unfortunately hidden by a porch of Victorian origin. The foundation is of brownstone, cut and scored.</i></p>			
<p>5. PHYSICAL CONDITION OF STRUCTURE Endangered ? Interior ? Exterior <i>Good</i></p>

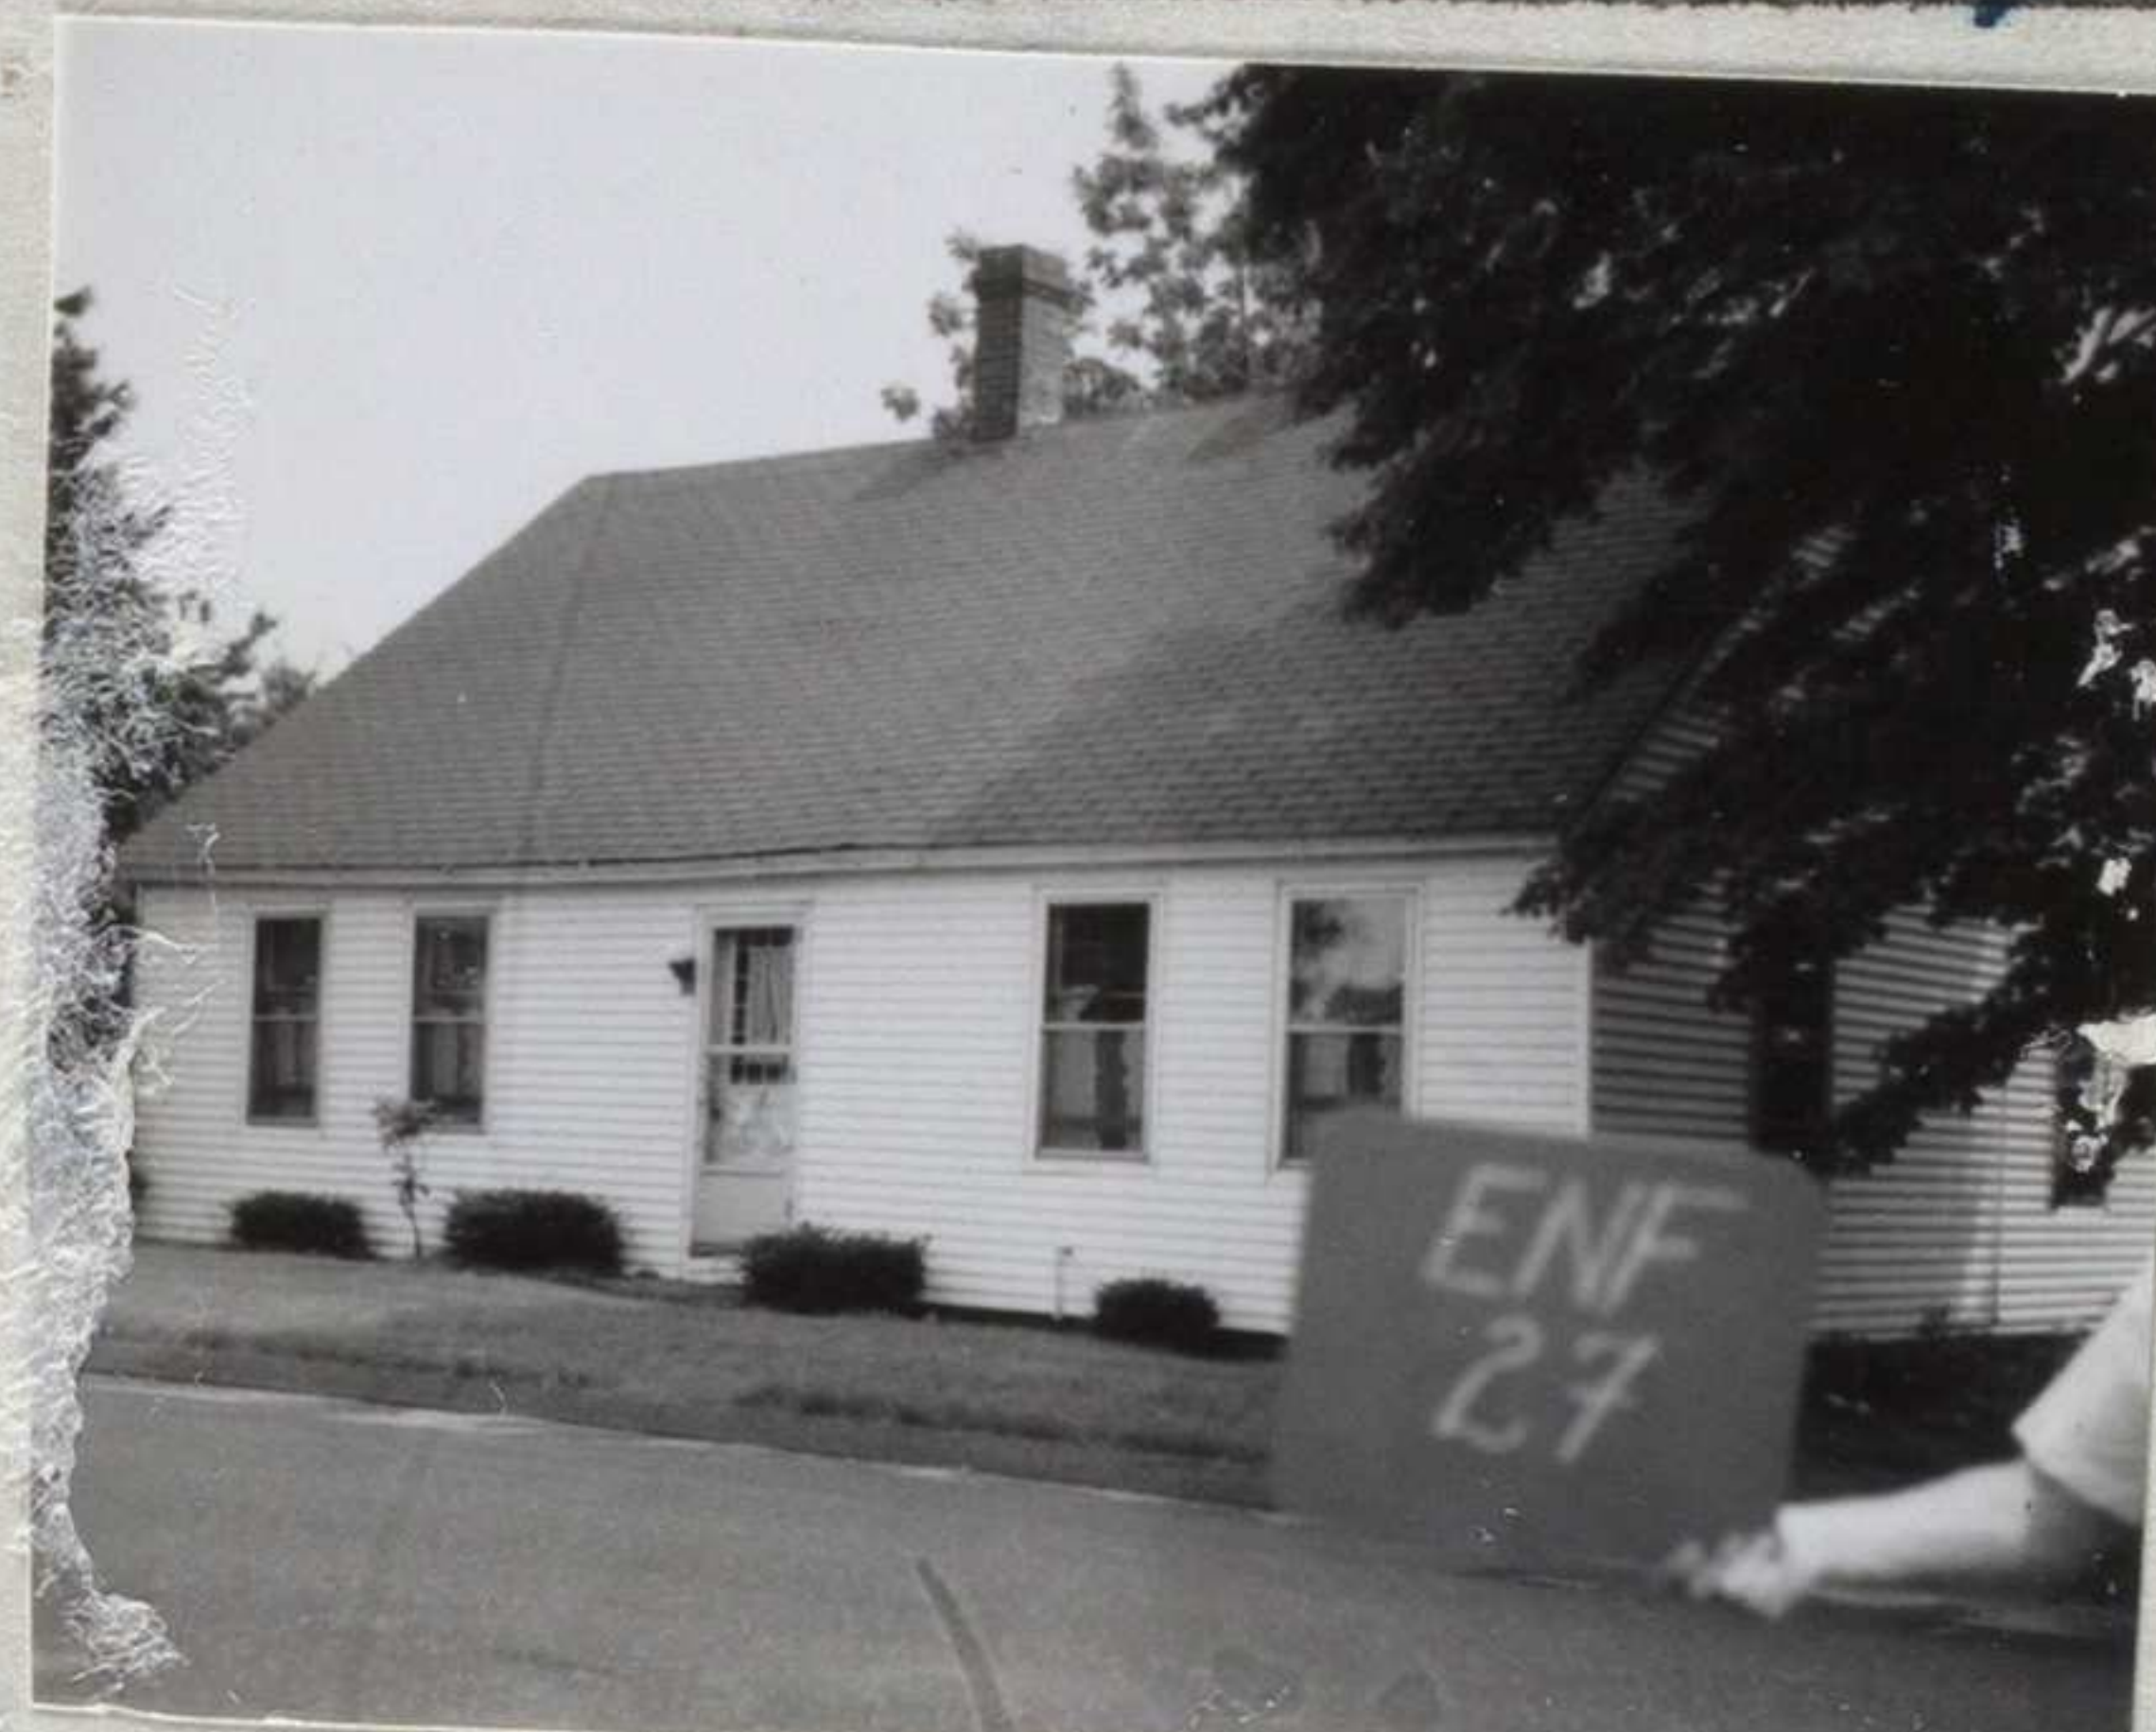
7. PHOTOGRAPH <i>ENF 27</i>

2. NAME DATE OR PERIOD <i>18th century</i> STYLE <i>Colonial (Cape Cod type)</i> ARCHITECT BUILDER	
		3. FOR LIBRARY OF CONGRESS USE	
4. NOTABLE FEATURES, HISTORICAL SIGNIFICANCE AND DESCRIPTION		OPEN TO PUBLIC <i>No.</i>	
<i>This house is distinguished by the 40° pitched massive roof which dominates its facade elevation. There are five bays and the two ridge centered chimneys are placed above the space between the 1st and 2nd, and the 4th and 5th bays. Unfortunately the door, windows and chimneys are not quite original. The foundation is of brick.</i>

5. PHYSICAL CONDITION OF STRUCTURE		Endangered <i>Yes</i> Interior <i>?</i> Exterior <i>poor</i>	
6. LOCATION MAP (Plan Optional)

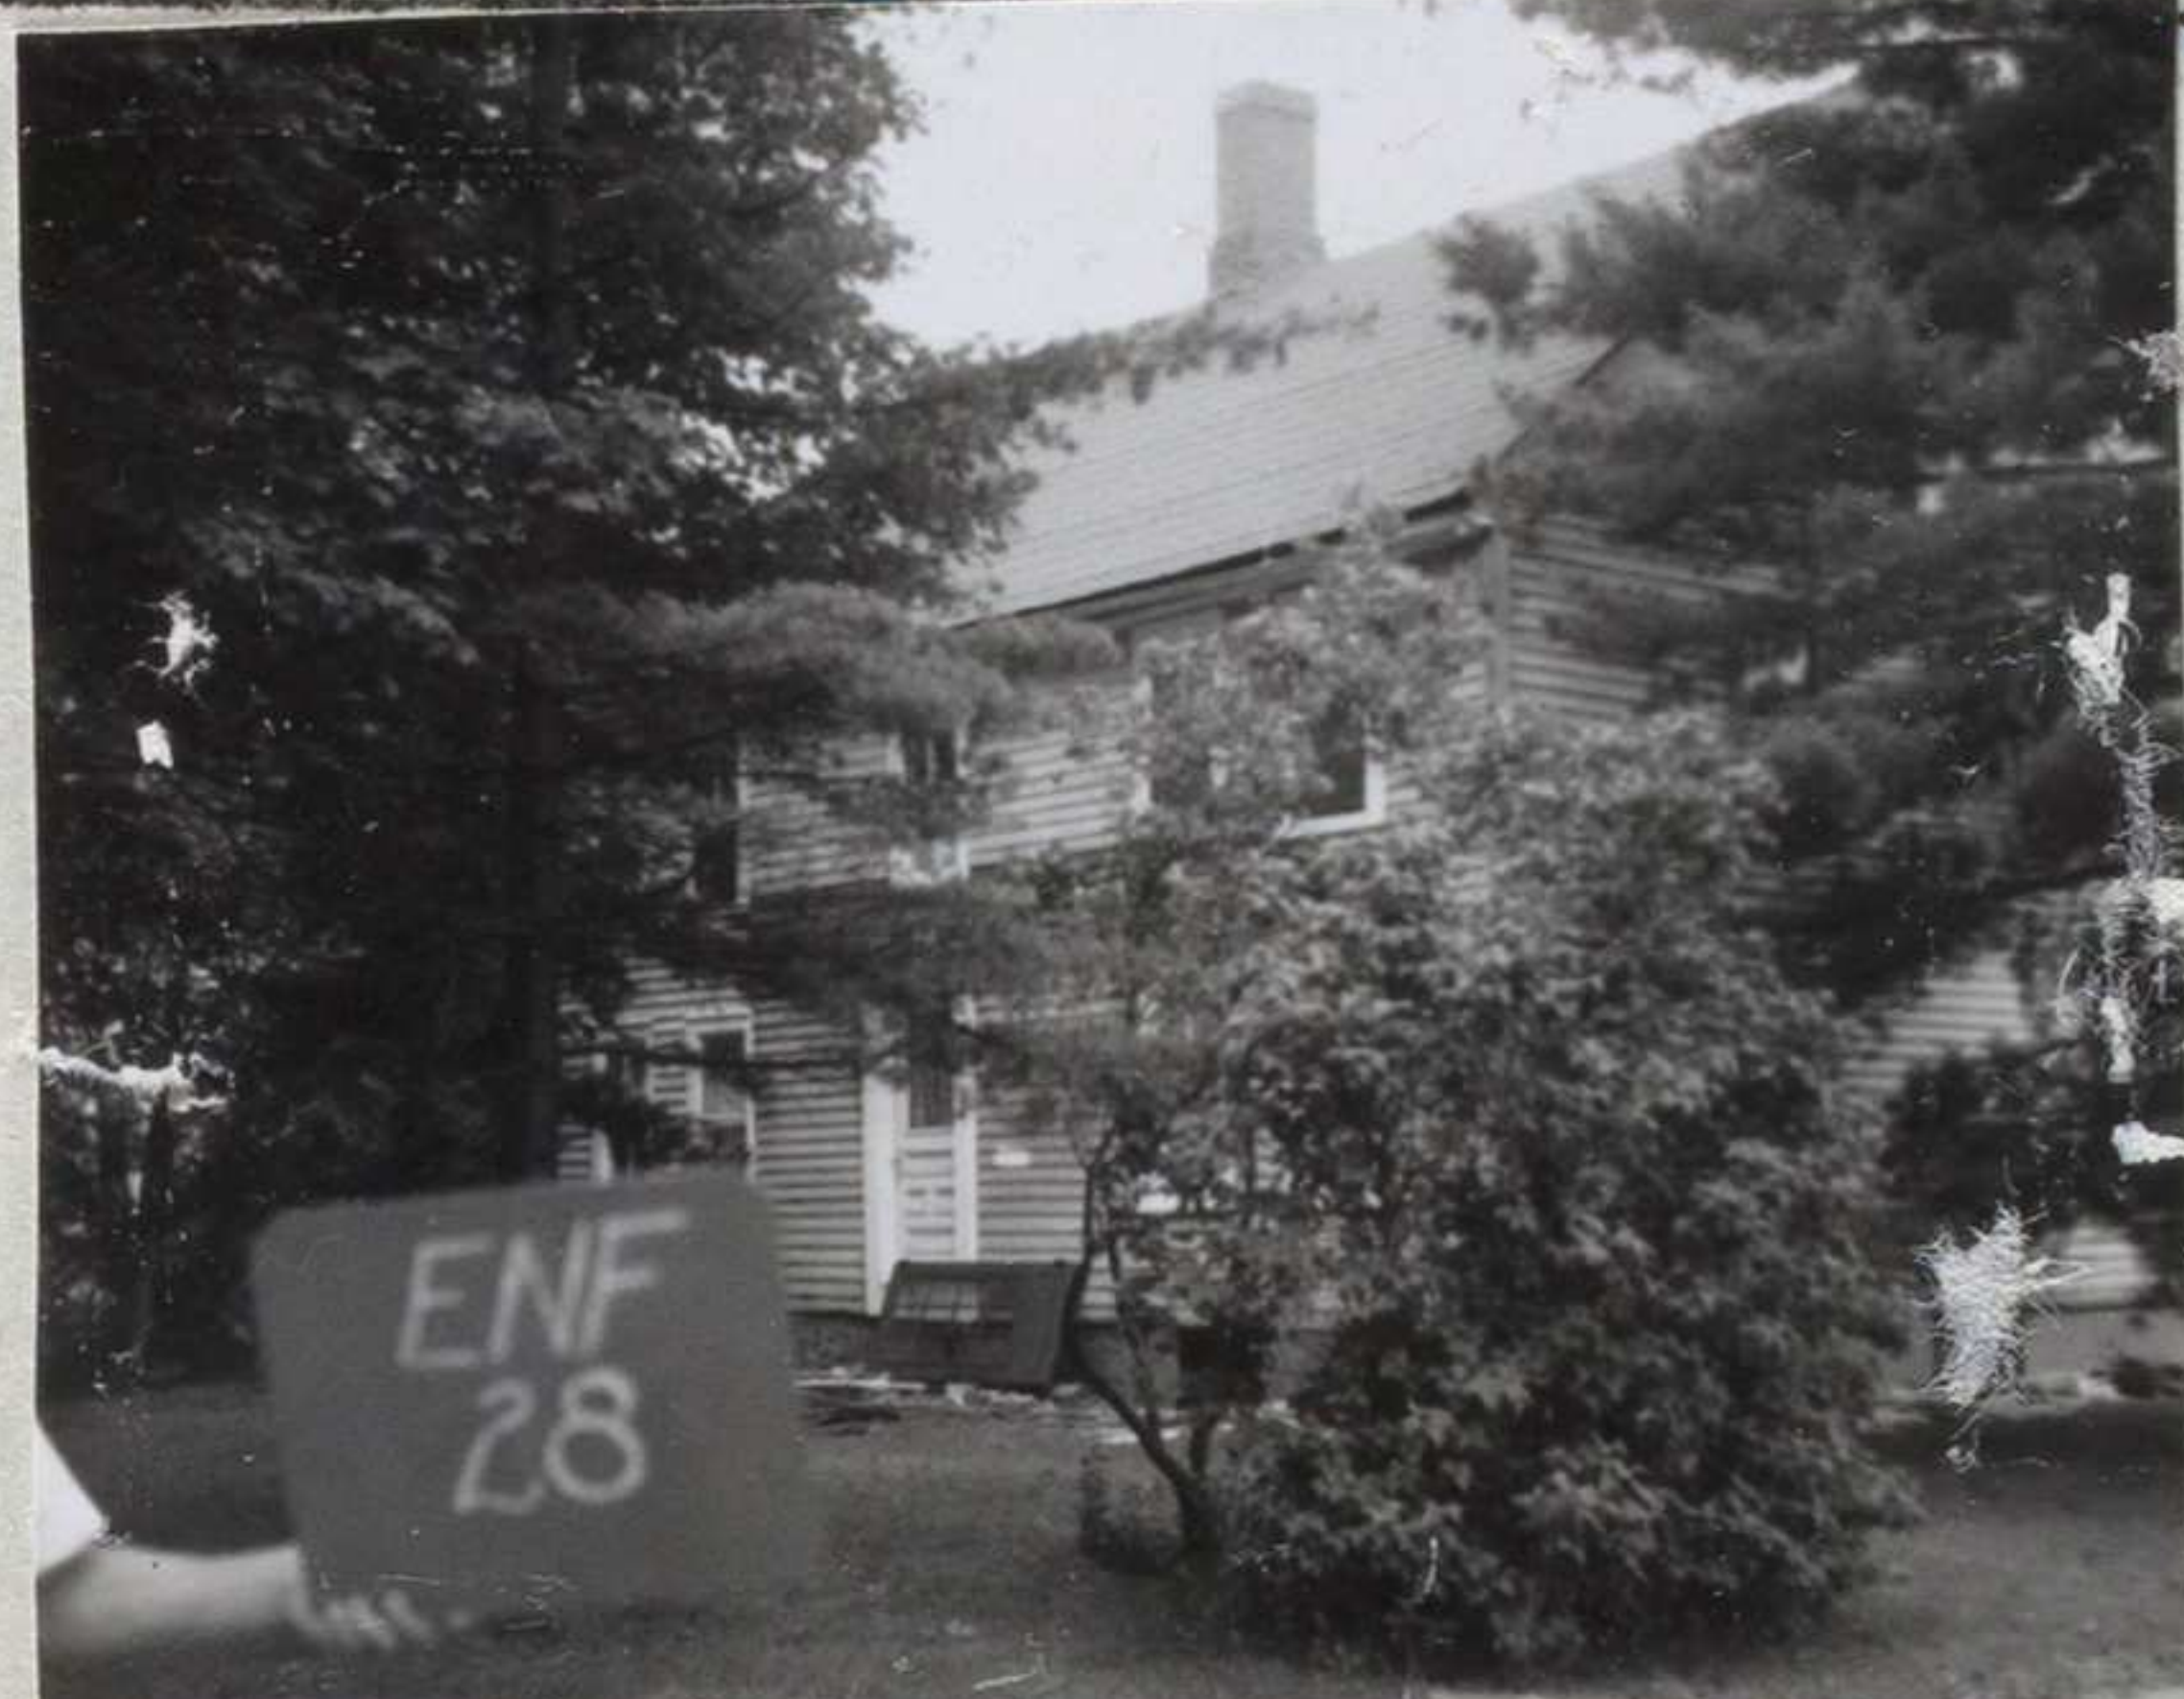
<p><i>Enf 28</i></p>

<p>1. STATE <i>Ct</i> COUNTY <i>Hartford</i> TOWN <i>Enfield</i> VICINITY STREET NO. <i>Sw corner of Abbe and Pleasant</i> ORIGINAL OWNER ? ORIGINAL USE <i>Residence</i> PRESENT OWNER ? PRESENT USE <i>Residence</i> WALL CONSTRUCTION <i>Clapboard</i> NO. OF STORIES <i>2</i></p>		<p>HISTORIC AMERICAN BUILDINGS SURVEY INVENTORY</p> <p>2. NAME DATE OR PERIOD <i>18th century</i> STYLE <i>Georgian</i> ARCHITECT BUILDER</p> <p>3. FOR LIBRARY OF CONGRESS USE</p>		
<p>4. NOTABLE FEATURES, HISTORICAL SIGNIFICANCE AND DESCRIPTION</p> <p><i>This house in very poor condition. Neither the door nor windows of the five bay facade are original. The central chimney is also a replacement. The roof is of a fairly steep pitch and the foundation is of brick. Although considerable repairs are under way, they appear to be architecturally unsympathetic.</i></p>		<p>OPEN TO PUBLIC <i>No.</i></p>		
<p>5. PHYSICAL CONDITION OF STRUCTURE</p> <p>Endangered ? Interior <i>poor?</i> Exterior <i>poor?</i></p>		<p>6. LOCATION MAP (Plan Optional)</p>

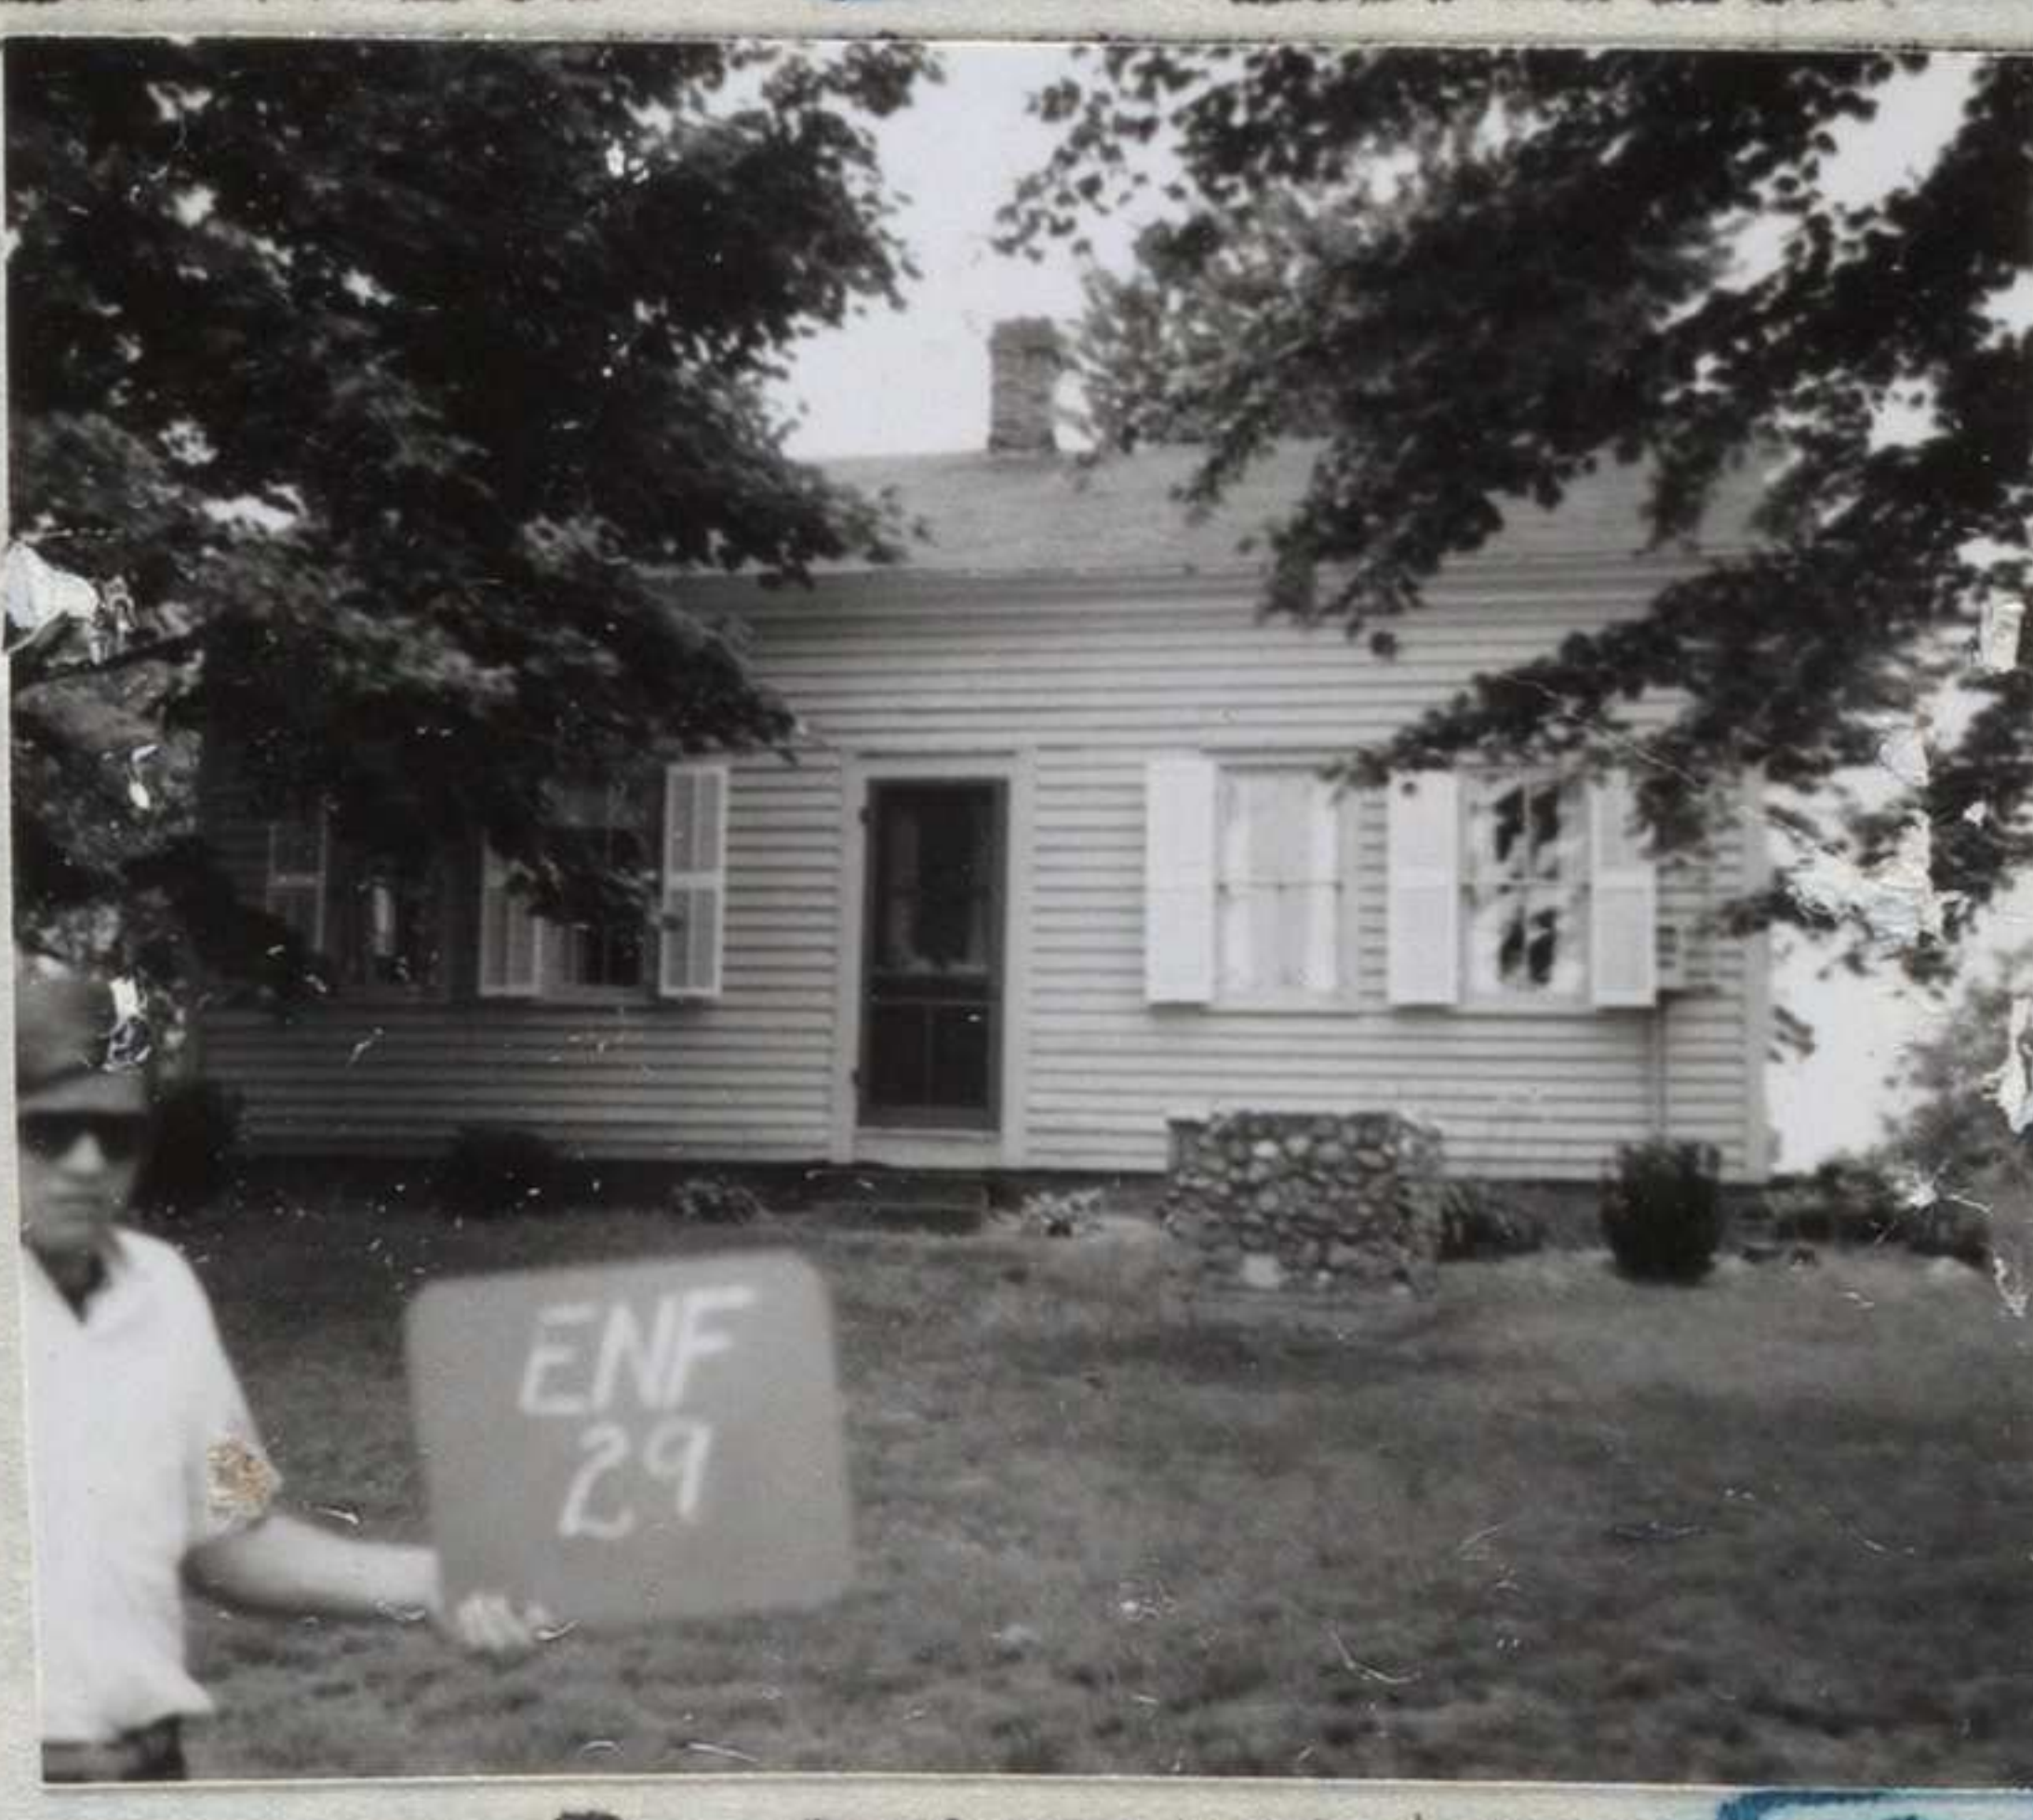
<p>7. PHOTOGRAPH <i>Enf 29</i></p>

<p>1. STATE <i>CT</i> COUNTY <i>Hartford</i> TOWN <i>Enfield</i> VICINITY STREET NO. <i>N of bend in Abbe Rd.</i></p> <p>ORIGINAL OWNER <i>Coleman?</i> ORIGINAL USE <i>Residence</i> PRESENT OWNER <i>?</i> PRESENT USE <i>Residence</i> WALL CONSTRUCTION <i>clapboard</i> NO. OF STORIES <i>1 1/2</i></p>	<p>HISTORIC AMERICAN BUILDINGS SURVEY INVENTORY</p> <p>2. NAME <i>Coleman House</i></p> <p>DATE OR PERIOD <i>1838</i> STYLE <i>Revival</i> ARCHITECT BUILDER</p> <p>3. FOR LIBRARY OF CONGRESS USE</p>
<p>4. NOTABLE FEATURES, HISTORICAL SIGNIFICANCE AND DESCRIPTION</p> <p style="text-align: right;">OPEN TO PUBLIC <i>NO</i></p> <p><i>This is simple old farmhouse or tenet house. It has five bays and although it is of the 1 1/2 story type there are no half windows on the facade. The roof is of shallow pitch punctuated at the middle by the chimney. It has recently had fine attention.</i></p>	
<p>5. PHYSICAL CONDITION OF STRUCTURE</p> <p>Endangered <i>?</i> Interior <i>?</i> Exterior <i>Good</i></p> <p>6. LOCATION MAP (Plan Optional)</p>

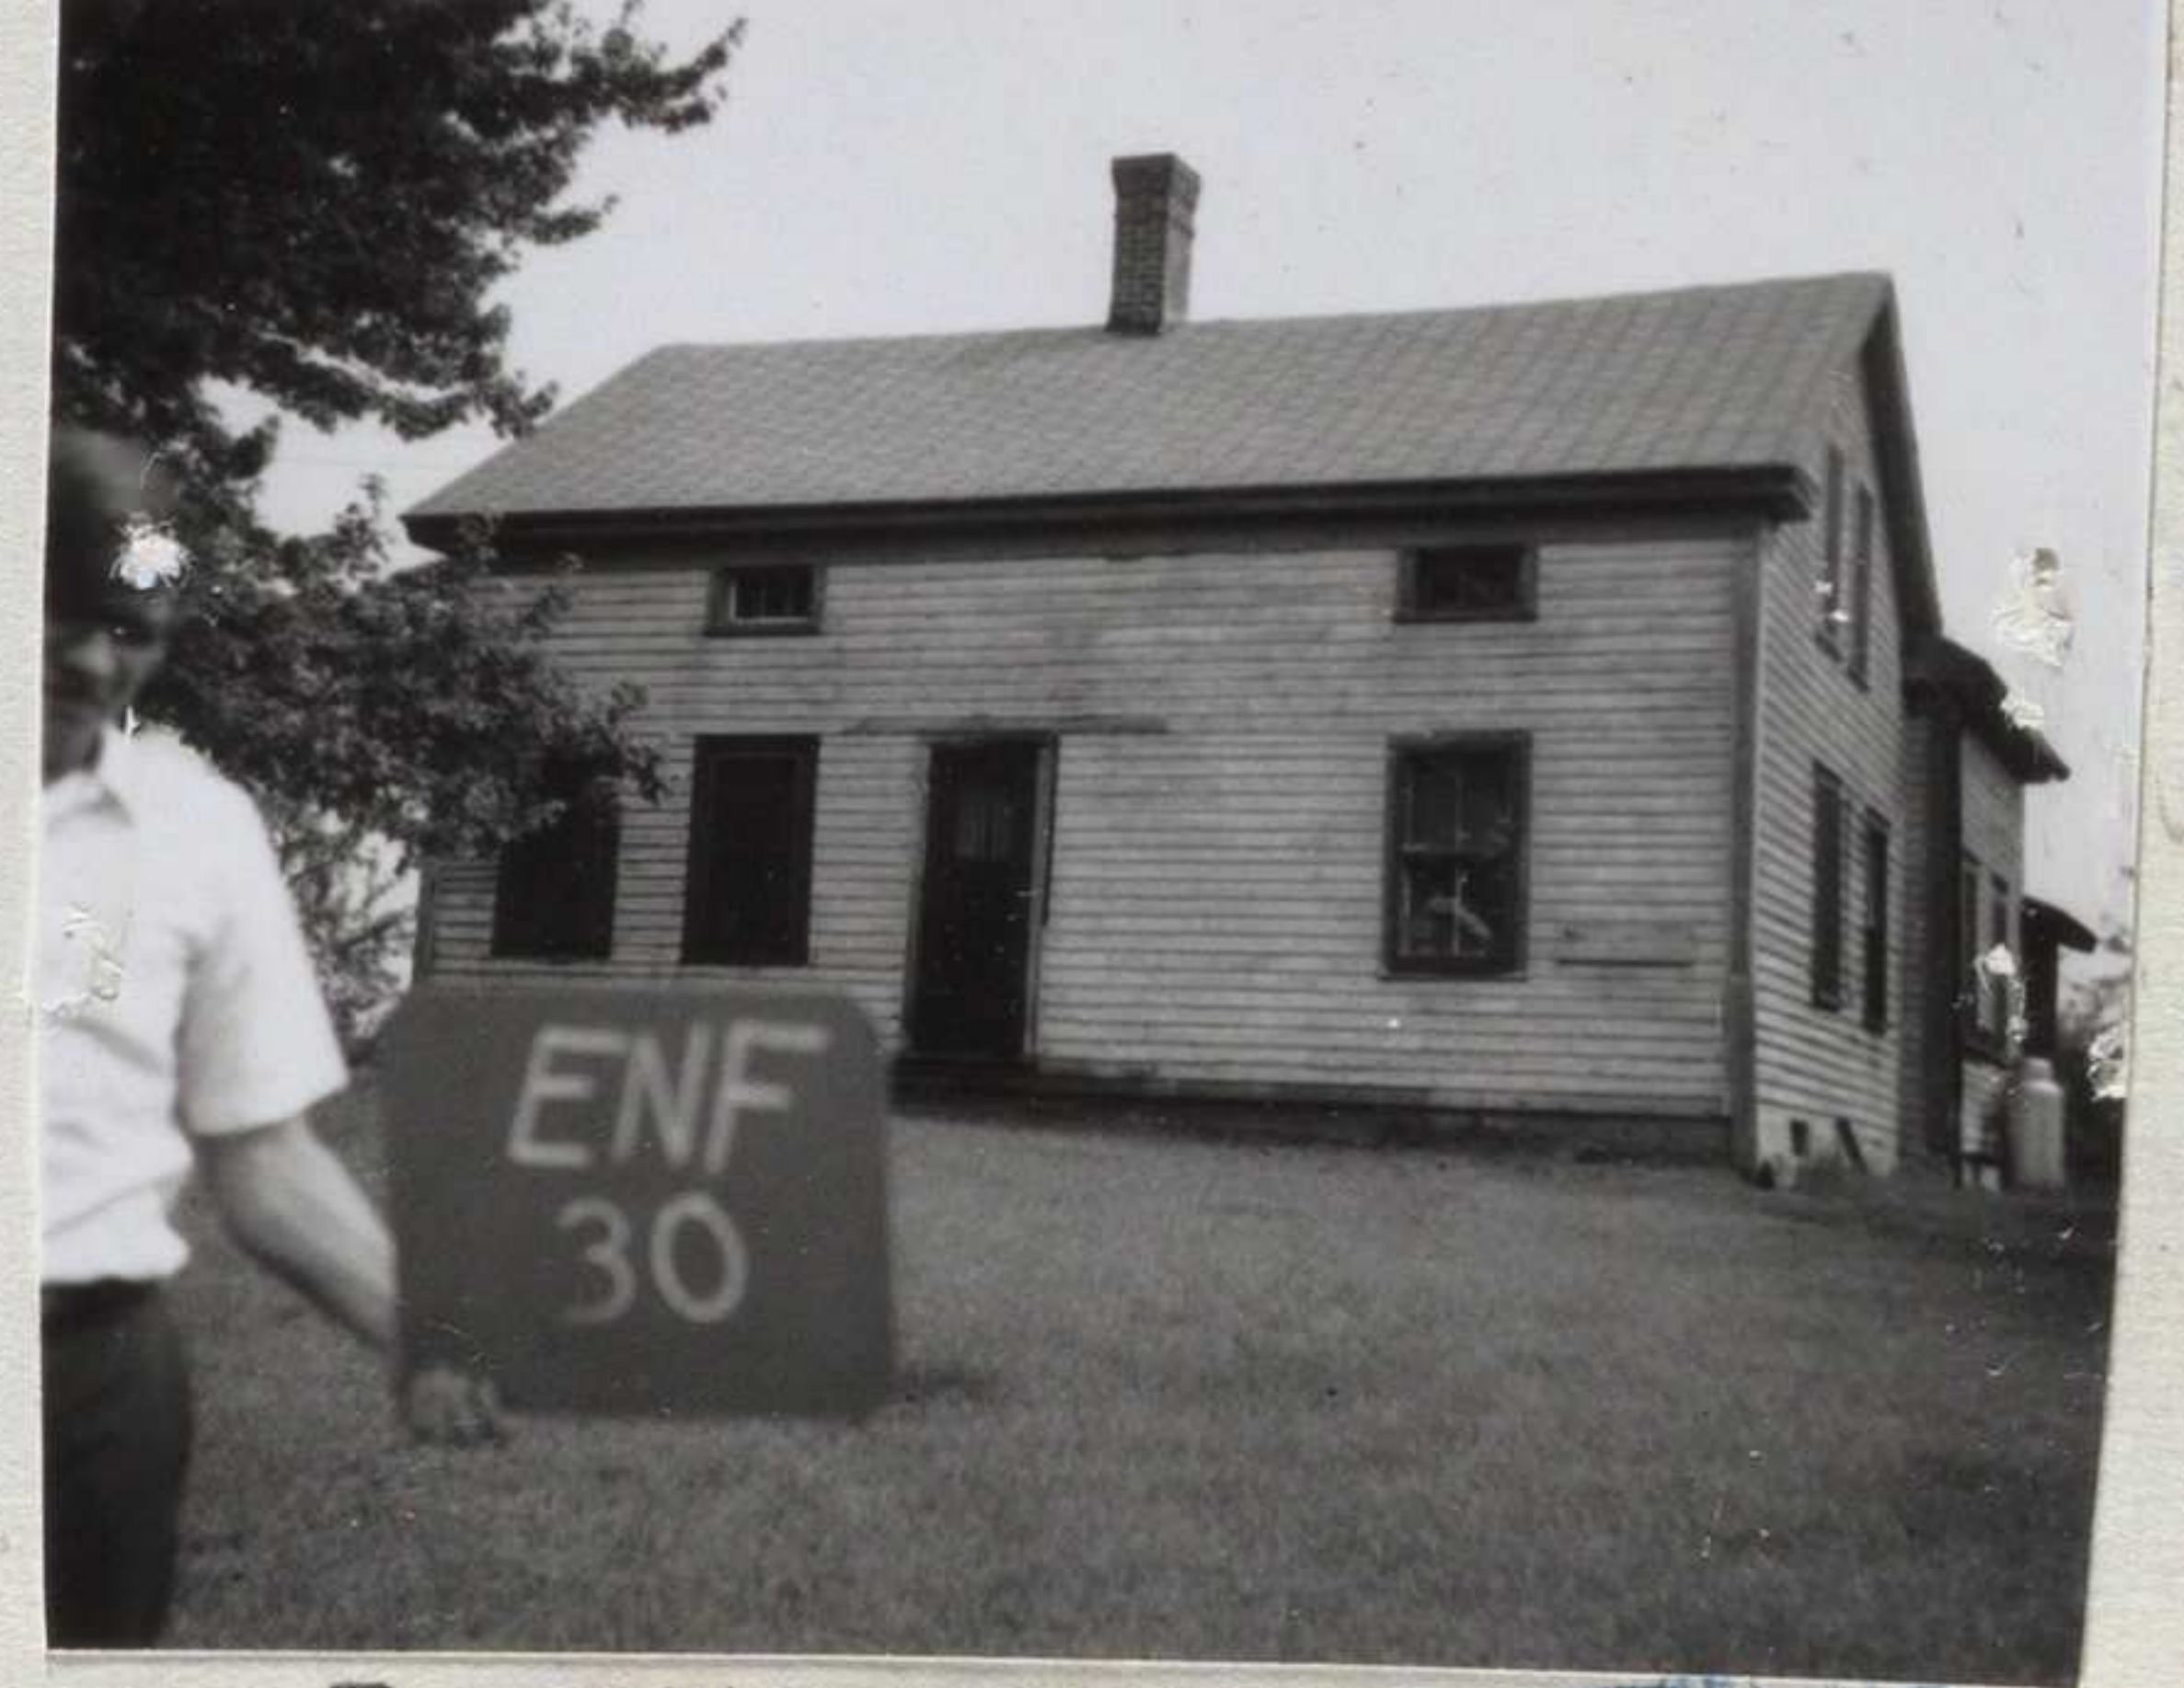
<p>7. PHOTOGRAPH <i>Enf 30</i></p>

<p>1. STATE <i>Ct</i> COUNTY <i>Hartford</i> TOWN <i>Enfield</i> VICINITY STREET NO. <i>Mullen Rd., 100 yds. w. of Steel Road.</i> ORIGINAL OWNER <i>Phelps</i> ORIGINAL USE <i>Residence</i> PRESENT OWNER <i>Mullen</i> * PRESENT USE <i>Residence</i> WALL CONSTRUCTION <i>clapboard</i> NO. OF STORIES <i>1 1/2</i></p>	<p>HISTORIC AMERICAN BUILDINGS SURVEY INVENTORY</p> <p>2. NAME <i>David Phelps House</i> DATE OR PERIOD <i>1780 (on sign)</i> STYLE <i>farmhouse</i> ARCHITECT BUILDER <i>David Phelps</i></p> <p>3. FOR LIBRARY OF CONGRESS USE</p>
<p>4. NOTABLE FEATURES, HISTORICAL SIGNIFICANCE AND DESCRIPTION OPEN TO PUBLIC <i>No.</i></p> <p><i>This house is said to have been built in 1780 but this seems rather doubtful, since its facade reflects the forms of the early nineteenth century. It appears to be of a five bay type, however windows are missing from this pattern. Perhaps it is the left three bays alone that ^{are} original. All features of this house are simple from the brick foundation to the trim. All elements are also in deplorable condition.</i></p>

<p>5. PHYSICAL CONDITION OF STRUCTURE Endangered <i>yes</i> Interior ? Exterior <i>poor.</i></p>
